## Test Report

Report No. A2220543665101

Sample Name Lithium ion Rechargeable Battery Module

Type T-BAT LR25

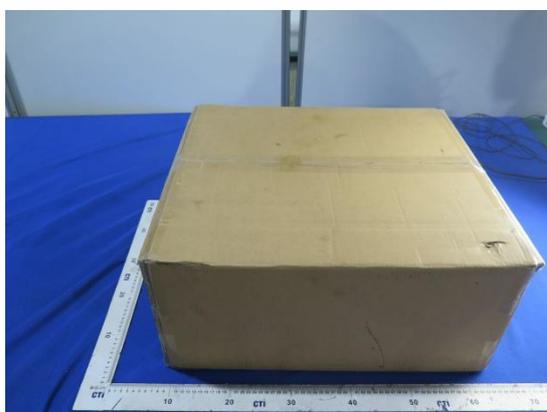
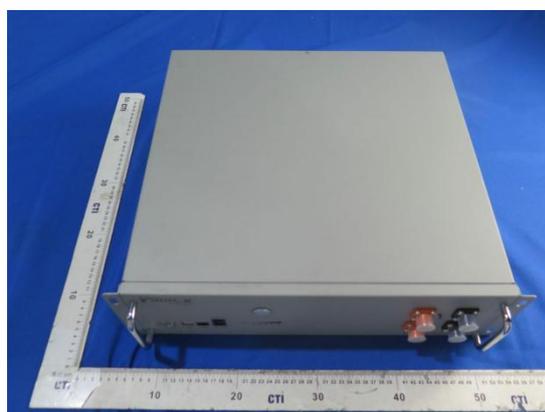
A2220543665101001

## Sample Photo(s)

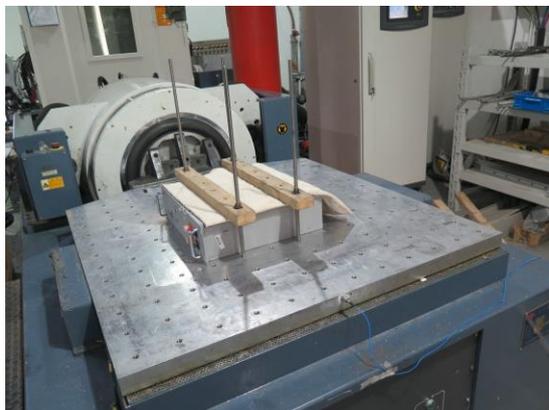
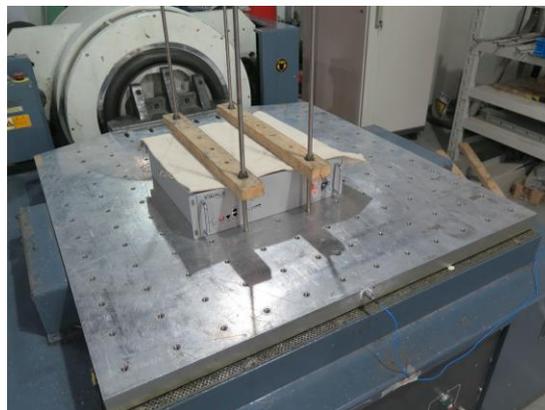
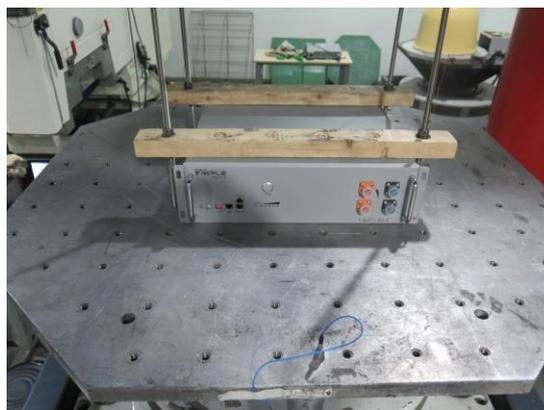
## Test Photo(s)

X

Y

Z

Sample No.	Test Result(s)
A2220543665101001	After the test, there was no visible mechanical damage on the sample by visual inspection.

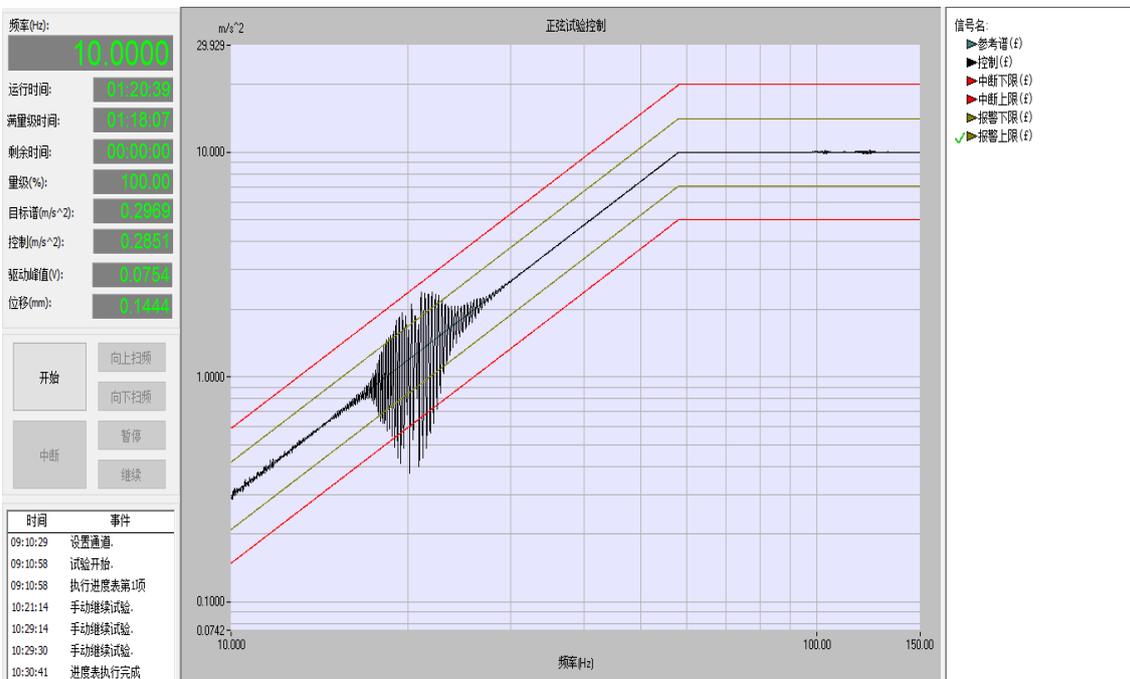
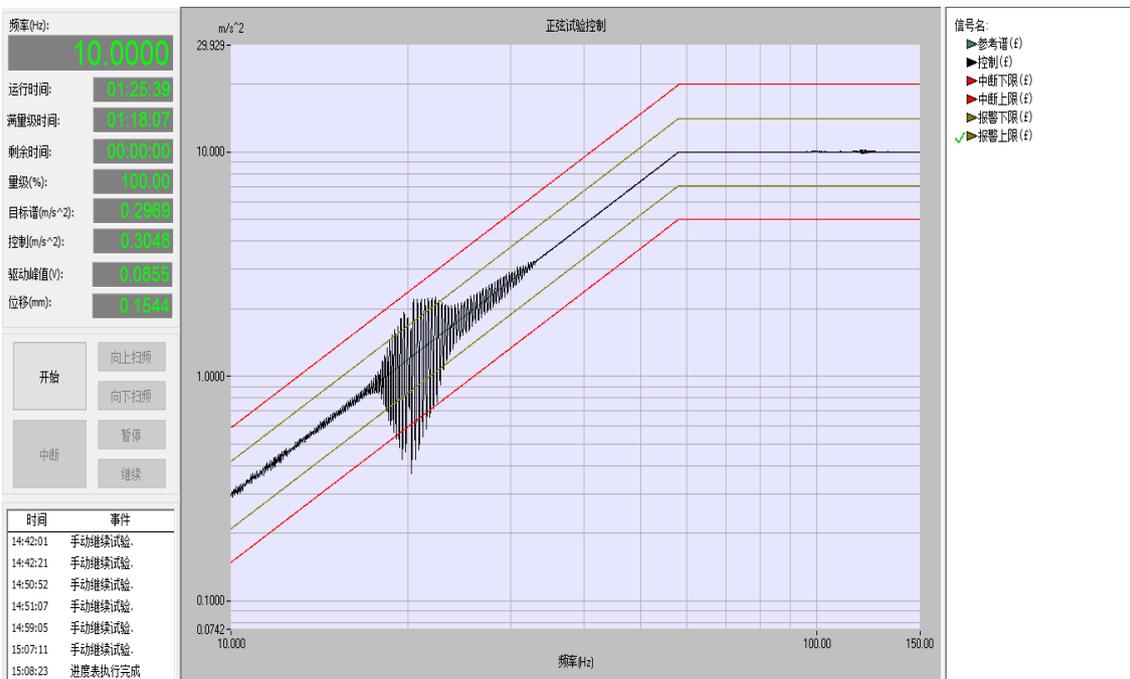
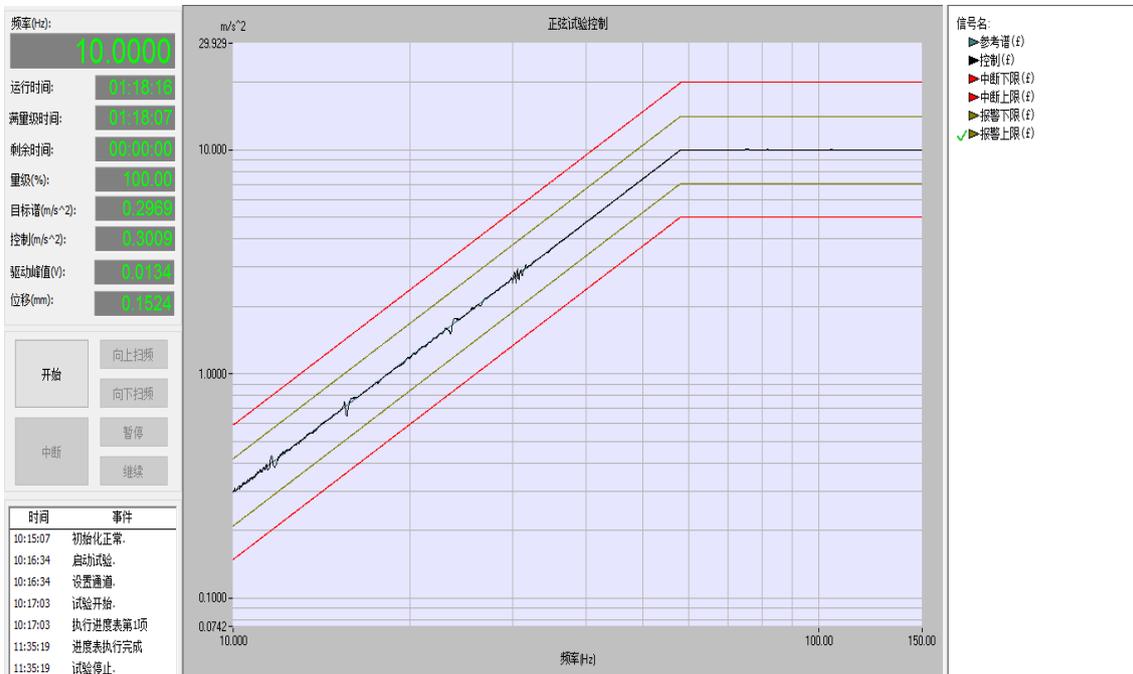
### Test Curve

X

Y

Z

Frequency (Hz)	Acceleration (m/s <sup>2</sup> )	Amplitude (mm)	Test Direction	Test duration
10-58	/	0.075	X、Y、Z	10cycles/axis
58-150	10	/		
Sweep rate: 1oct/min

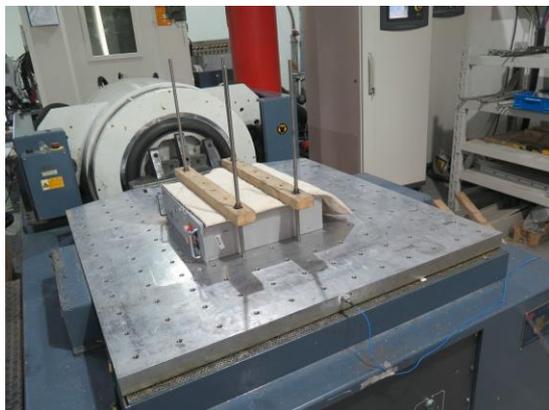
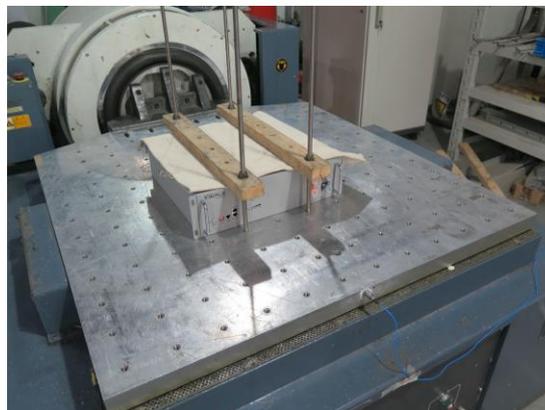
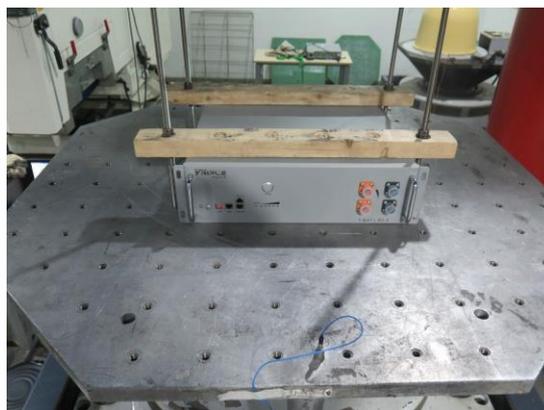
## Test Photo(s)

X

Y

Z

Sample No.	Test Result(s)
A2220543665101001	After the test, there was no visible mechanical damage on the sample by visual inspection.

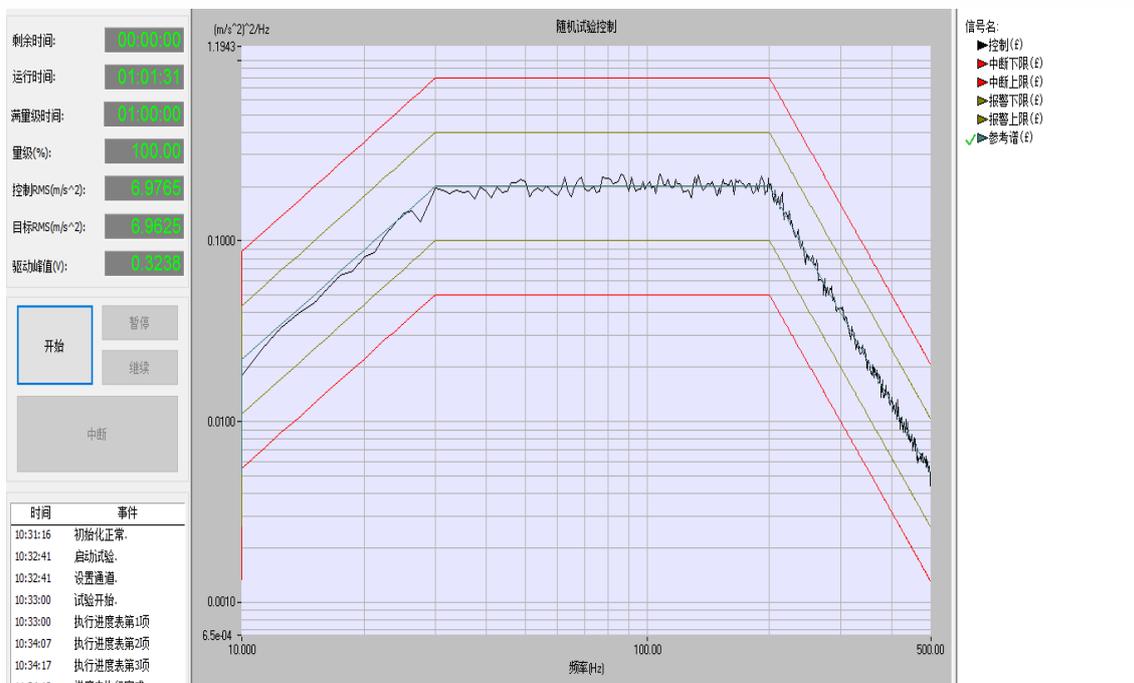
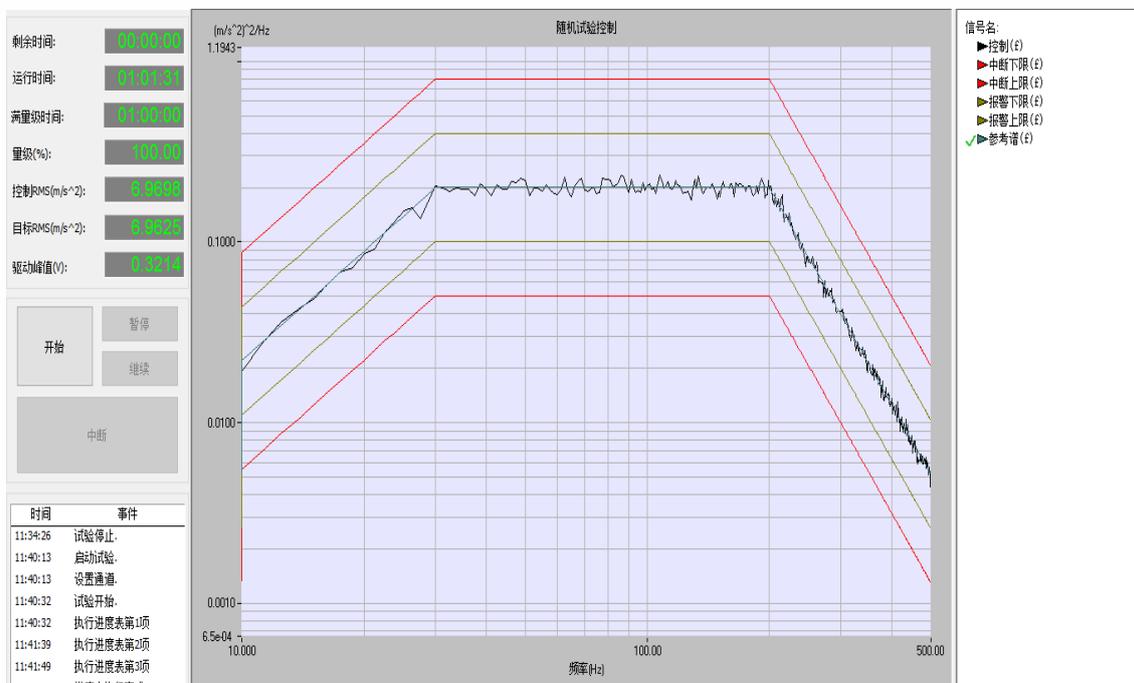
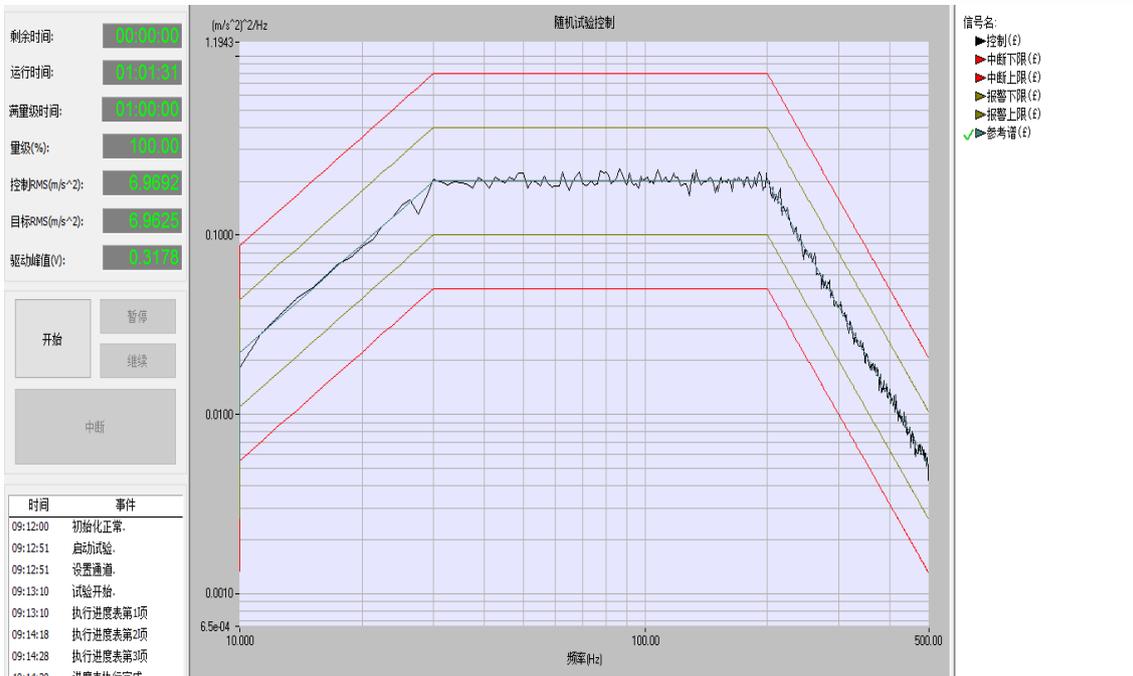
### Test Curve

X

Y

Z

Frequency (Hz)	PSD(( m/s <sup>2</sup> ) <sup>2</sup> /Hz)	Test direction	Test duration	g rms
10	1.0	X、Y、Z	1h/axis	7.0
10	1.0			
200	1.0			
500	0.3

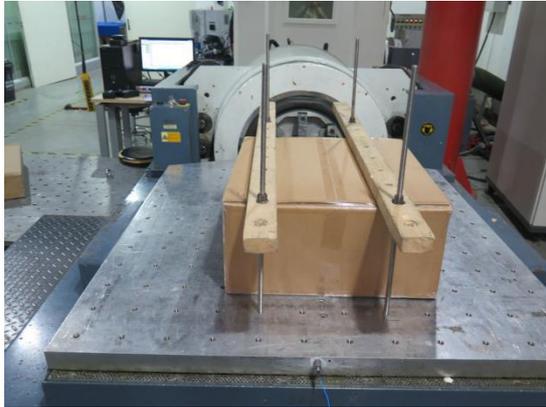
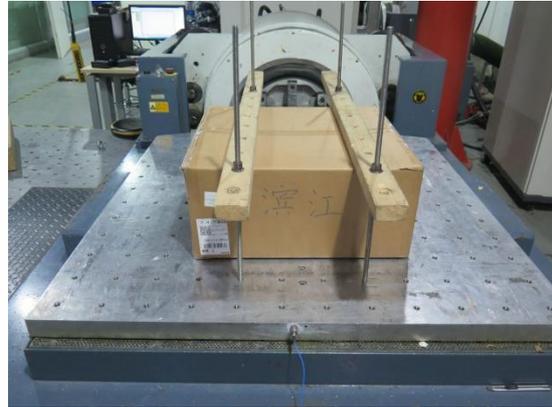
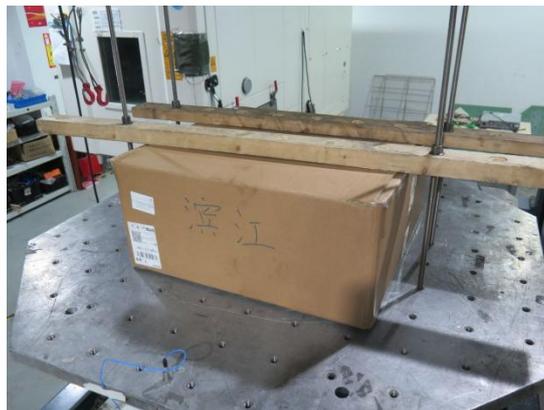
## Test Photo(s)

X

Y

Z

Sample No.	Test Result(s)
A2220543665101001	After the test, there was no visible mechanical damage on the sample by visual inspection.

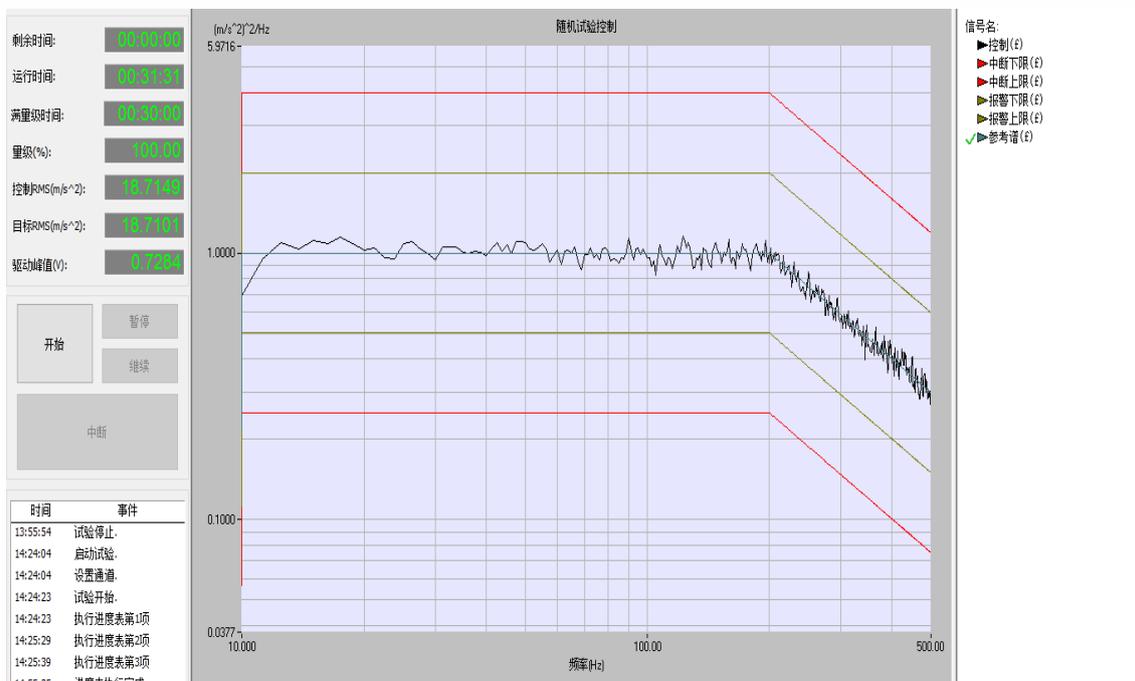
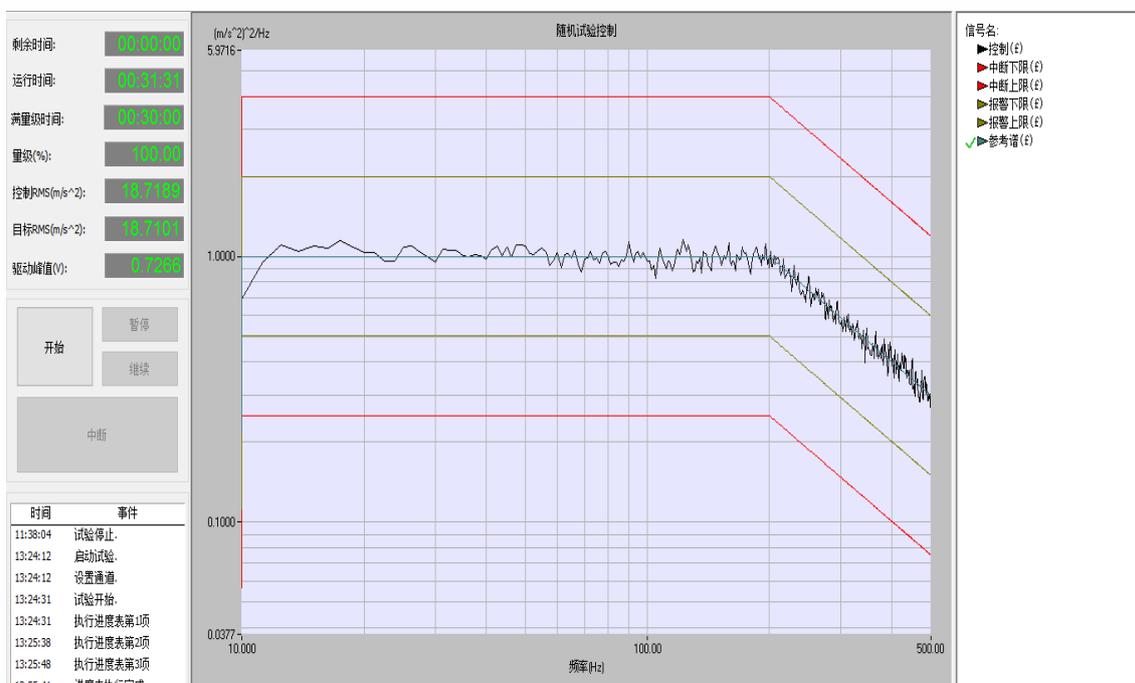
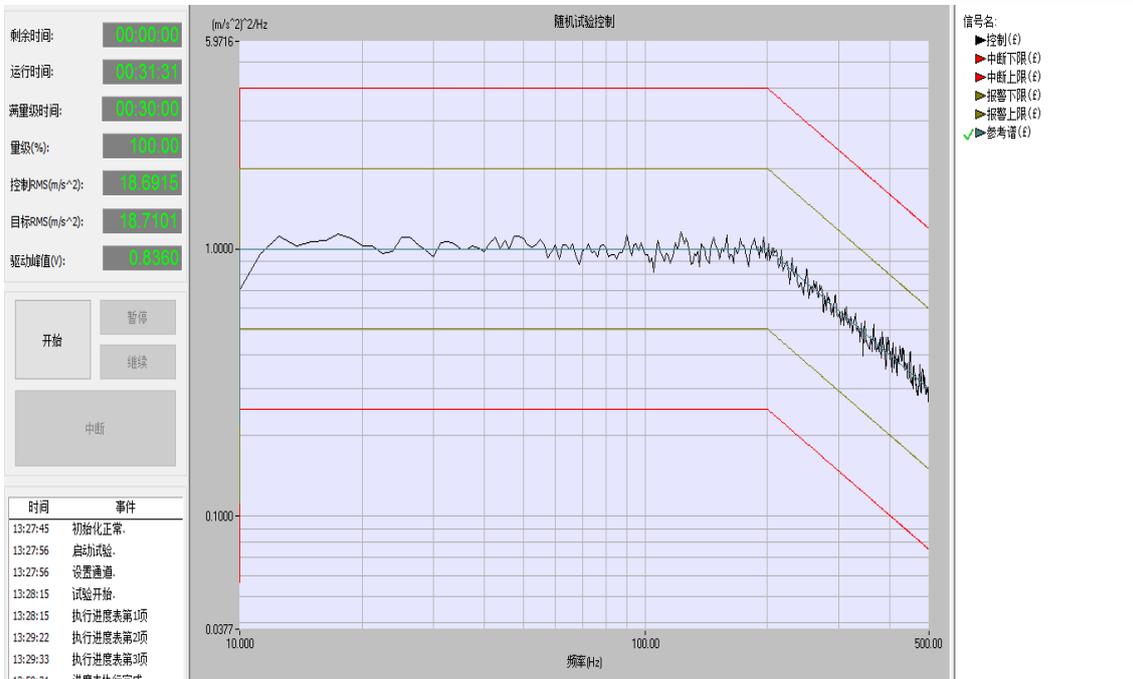
### Test Curve

X

Y

Z

Frequency (Hz)	PSD(( m/s <sup>2</sup> ) <sup>2</sup> /Hz)	Test direction	Test duration	g rms
10	0.022	X、Y、Z	30min/axis	18.7
30	0.2			
200	0.2			
500	0.0052

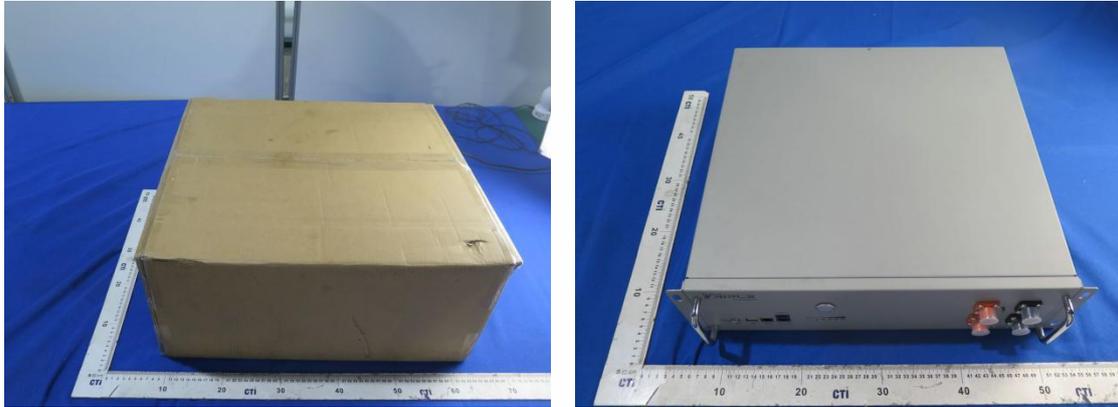
A2220543665101001

**Sample Photo(s) after the test**
